Investigation about ancient mortars and plasters in the Mondovì cathedral (Cuneo, Italy)

Maria Elena Moschella¹, Walter Canavesio², Mariano Cristellotti¹ and Emanuele Costa^{3,*}

Abstract

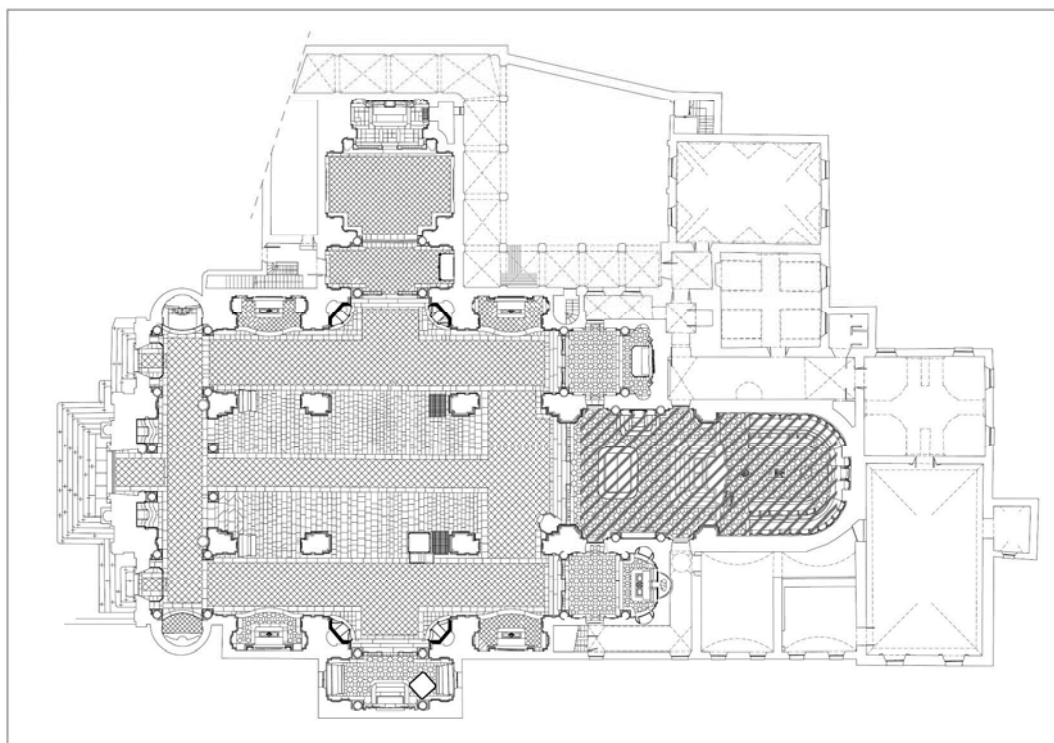
Figure 3. Plan of the Cathedral. The total length of the Church is about 56 m, whereas the width is 24 m. Courtesy of GEOMAR.IT (www.geomar.it).

The San Donato Cathedral of Mondovì (Cuneo Province, North-West Italy, Figure 1) is an 18th century building, by the great architect from Mondovì Francesco Gallo (Figure 2). Erected in 1743 on the structures of the ancient Franciscan church (Grassi, 1789; Casalis, 1842), the building works lasted for decades and were followed by important architects such as Bernardo Antonio Vittone and the first architect of the king, Benedetto Alfieri. The façade was built in 1777 by master builder Quadrone with structural stone from Vico, following faithfully the design of architect Gallo. The building is an impressive church, it has a three naves structure, with lateral chapels and a large transept where two lateral chapels are situated on the side of the presbytery and two large chapels at the heads. It is of a considerable length of 56 meters and a width of 24 meters, and a wide dome on corbels is located at the crossing of the ribs (Figure 3).

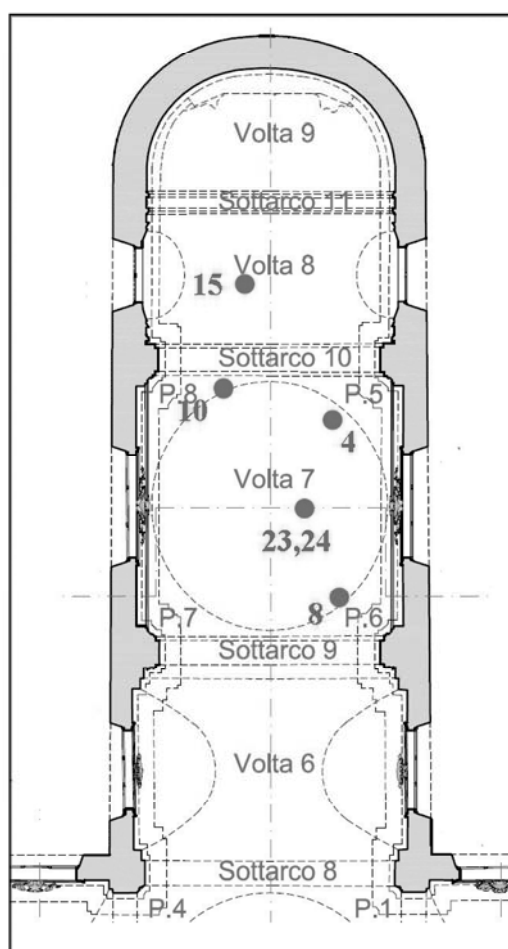
Figure 5. Sampling position in the north portion of the Church. Courtesy of GEOMAR.IT (www.geomar.it).

All the samples were picked from the northern part of the church, from the upper portion of the pictorial cycle (Figure 5; Table 1), where the restoration works are now in progress. For the investigation of pigment layers we used different techniques like SEM-EDS, FT-IR, Raman Spectroscopy and ICP-OES (Artioli, 2010), for the investigation of mortar layers -conducted extensively on resin included polished sections- we used Optical Microscopy (OM) and Scanning Electron Microscopy (SEM) supported by Energy Dispersive microprobe Spectroscopy (EDS) (Reed, 2005; Severin, 2004).

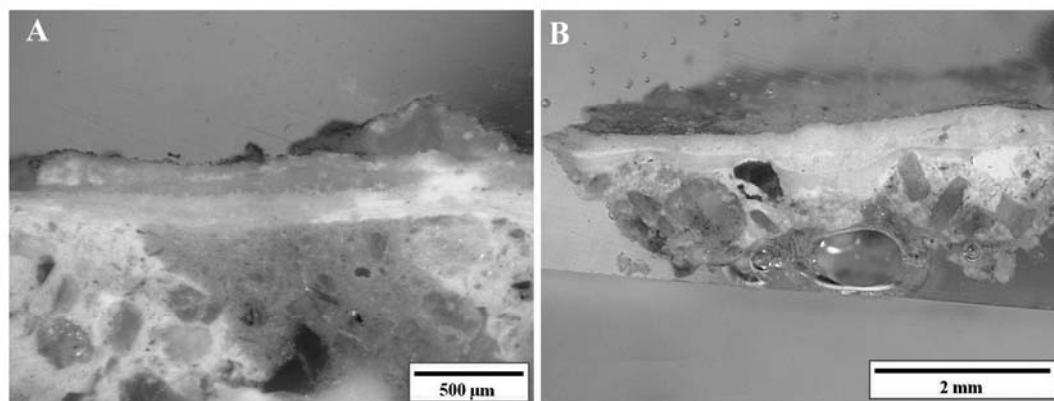
Figure 8. A) The finishing layer is composed of a very compact and homogeneous plaster, milky white, fine textured and almost without aggregate, coated in many layers (as shown in Figure 8). Sample 10 taken in OM picture; B) Another portion of the white brilliant plaster in an area of sample 24. The layer is very thin, but it follows the rough surface and in some place has a higher thickness.

A thin finishing material made of lime and magnesian lime lies on the surface of the mid '700 mortar (Figure 8A and 8B). The total thickness of this layer is usually less than 1 mm, but in this very subtle coating we can recognize up to seven different strata of variable composition (Figure 9). The layer is fine grained and, in optical microscopy observation, shows a very brilliant-white finishing. Only in one sample we noticed a blackish-gray horizon containing a little amount of charcoal. In one of the strata we also found lime lumps. This sequence was probably obtained by multiple brush application of a diluted lime suspension (whitewash).

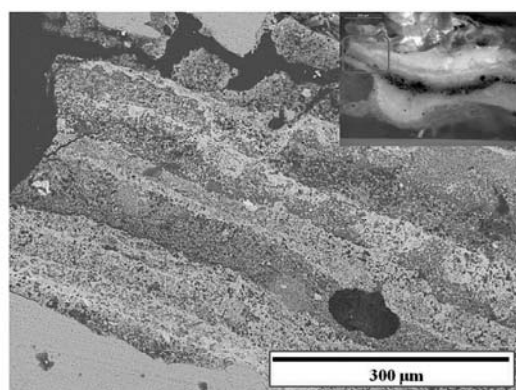
Figure 9. The white mid '700 plaster observed in BSE image shows its nature composed by multiple layer (the small insert is the same area in OM picture). Light gray levels are calcium rich, whereas darker levels are magnesium-rich. Up to seven different layers could be identified in this high resolution image.

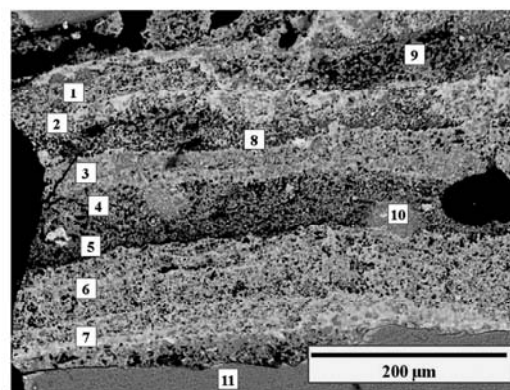
Figure 10. A false colour EDS map of the same area of Figure 9, with the analysis localizations (results are shown in Table 2). In this image Ca concentration is coded in green, Mg concentration is coded in red and silicon content is rendered in blue. We can clearly observe a silica grain at the base of the strata, but there is no silica in the magnesian lime of the plaster. Different layers have different compositions, alternating magnesium-rich lime to magnesium-poor lime.

In the picture (Figure 10) the stacking of the layers is clearly visible. False colour EDS map shows compositional differences, confirmed by EDS analysis (Table 2). All the analyses were obtained on small area to mediate the imperfection and to have a better fitting with higher count ratio. Sum of oxides is recalculated to approximate 100% total weight, despite of the presence of water and other substances not analyzed (Franzini, 1999). Strong variations in the Mg/Ca can be observed. Analysis n. 11 was performed in a quartz grain. The different distribution of magnesium in the layer rises a question: why are there so many strata in this layer? The sampled surface is around 15 m high from the church floor, a white coat periodically painted for cleaning purpose every few years is quite unconvincing. The entire layer was probably made during the same period while the wooden scaffolding was still in place. But if the work was done in the same time frame, why are

there so big differences in composition between layers? We hypothesize the presence of Mg-containing silicatic minerals, but no silicon is showed by EDS spectra.

Table 2. The EDS analysis from different areas of the EDS Map of Figure 10. Values are in weight %

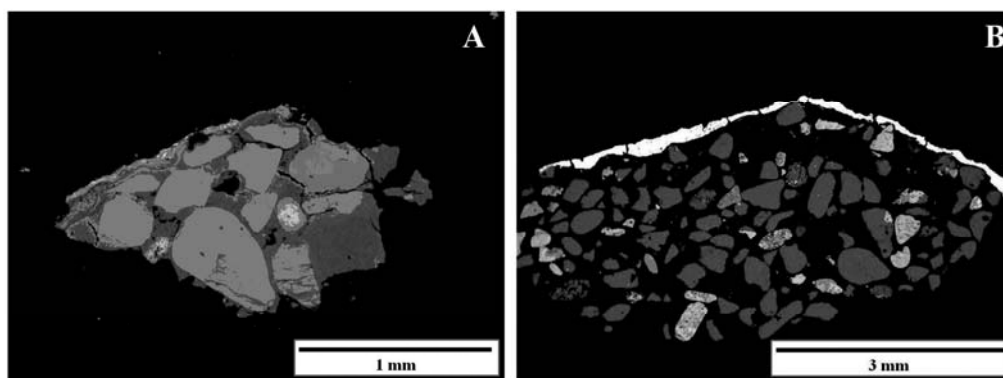
Figure 14. A) A false colour BSE image of sample 8 mid '800 mortar. Silica (quartz) granules are light blue whereas feldspars range from green to orange; B) A false colour BSE image of sample 15 mid '800 mortar. Silica (quartz) granules are light blue whereas feldspars range from green to orange.

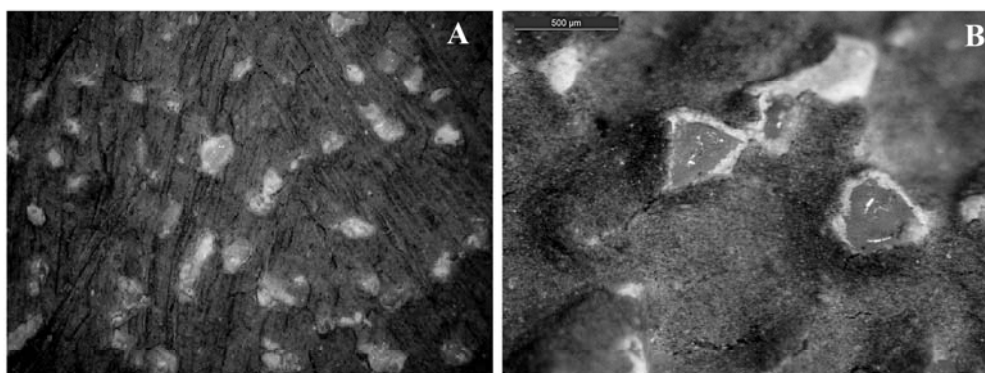
Figure 15. A) A micro-camera image of a pictorial surface with the whitish tiny dots due to detach of the paint layer in correspondence of the quartz grain; B) Magnification of the previous area. The quartz grain protrudes from the surface causing a loss of pictorial layer. The white thin gypsum layer is also visible between the quartz and the paint film.

Macrophotography of the surface and SEM imaging proved that the distribution of the white dots on the pigment layers matches with the protrusion of quartz particles from the mortar: the adhesion between quartz and the pictorial layer was not strong enough to ensure the grasping of the paint for about 150 years (Figure 15A and 15B).

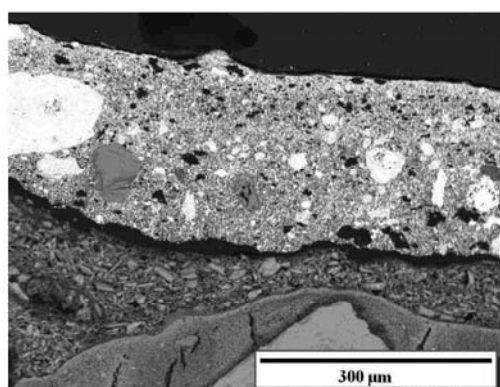
Figure 16. The gypsum layer below the pictorial layer (above) and the mortar (at the base). The texture made of tiny elongated microcrystals of gypsum is clearly pictured in the BSE-SEM image. This layer was requested by the painters as a preparative surface for the painting cycle.

This layer has been found in almost all samples. The gypsum (which nature was confirmed by EDS analysis) (Figure 16) is in a dense polycrystalline form, represented by an aggregate of minute bacillar cristallites, few micrometers long and very thin; the total thickness of the layer is usually below 100 micrometers, following the roughness and the cavities of the mortar surface

below. The reason for that could be that this layer has been painted "a secco", or with organic ligands. For these painting techniques it's necessary to prepare the wall with a layer called "imprimatura", a uniform background for paintings. Usually this is made of very fine lime, but sometimes it may be made of gypsum mixed with water, glue or milk (Forti, 1937).
